AIMING TO IMPROVE THE ENERGY EFFICIENCY OF APARTMENT BLOCKS

Dolgozó 2, Budapest, Hungary

Background

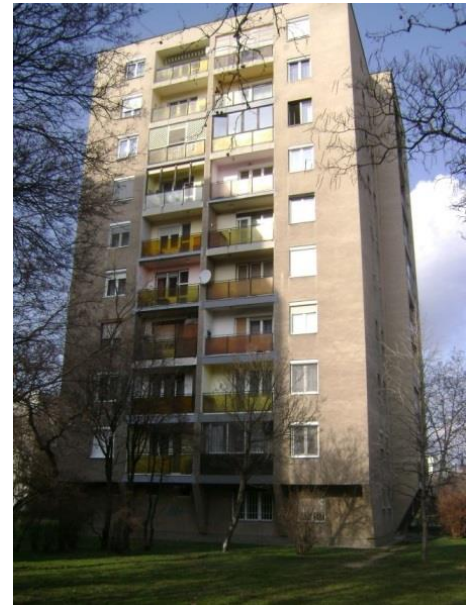
Case study block

This multi-storey residential building situated in Budapest was built in 1966. The building has 36 dwellings, all of which are under private ownership. The building's communal areas are owned by a housing association.

The building is constructed of very thin concrete walls and a flat roof without insulation. The block is serviced by district heating.

As a result the energy efficiency measures recommended were: external wall insulation, flat roof insulation and double glazed windows.
